*Summary Phase IA and Full Phase IB Archaeological  
Field Reconnaissance Report of Phase 2 of the  
Martville Mine in the Town of Sterling, Cayuga  
County, New York*

***OPRHP #14PR03874***

***Reports of Investigations 15FR01***

*Phase of Survey:* Summary Phase IA and full Phase IB

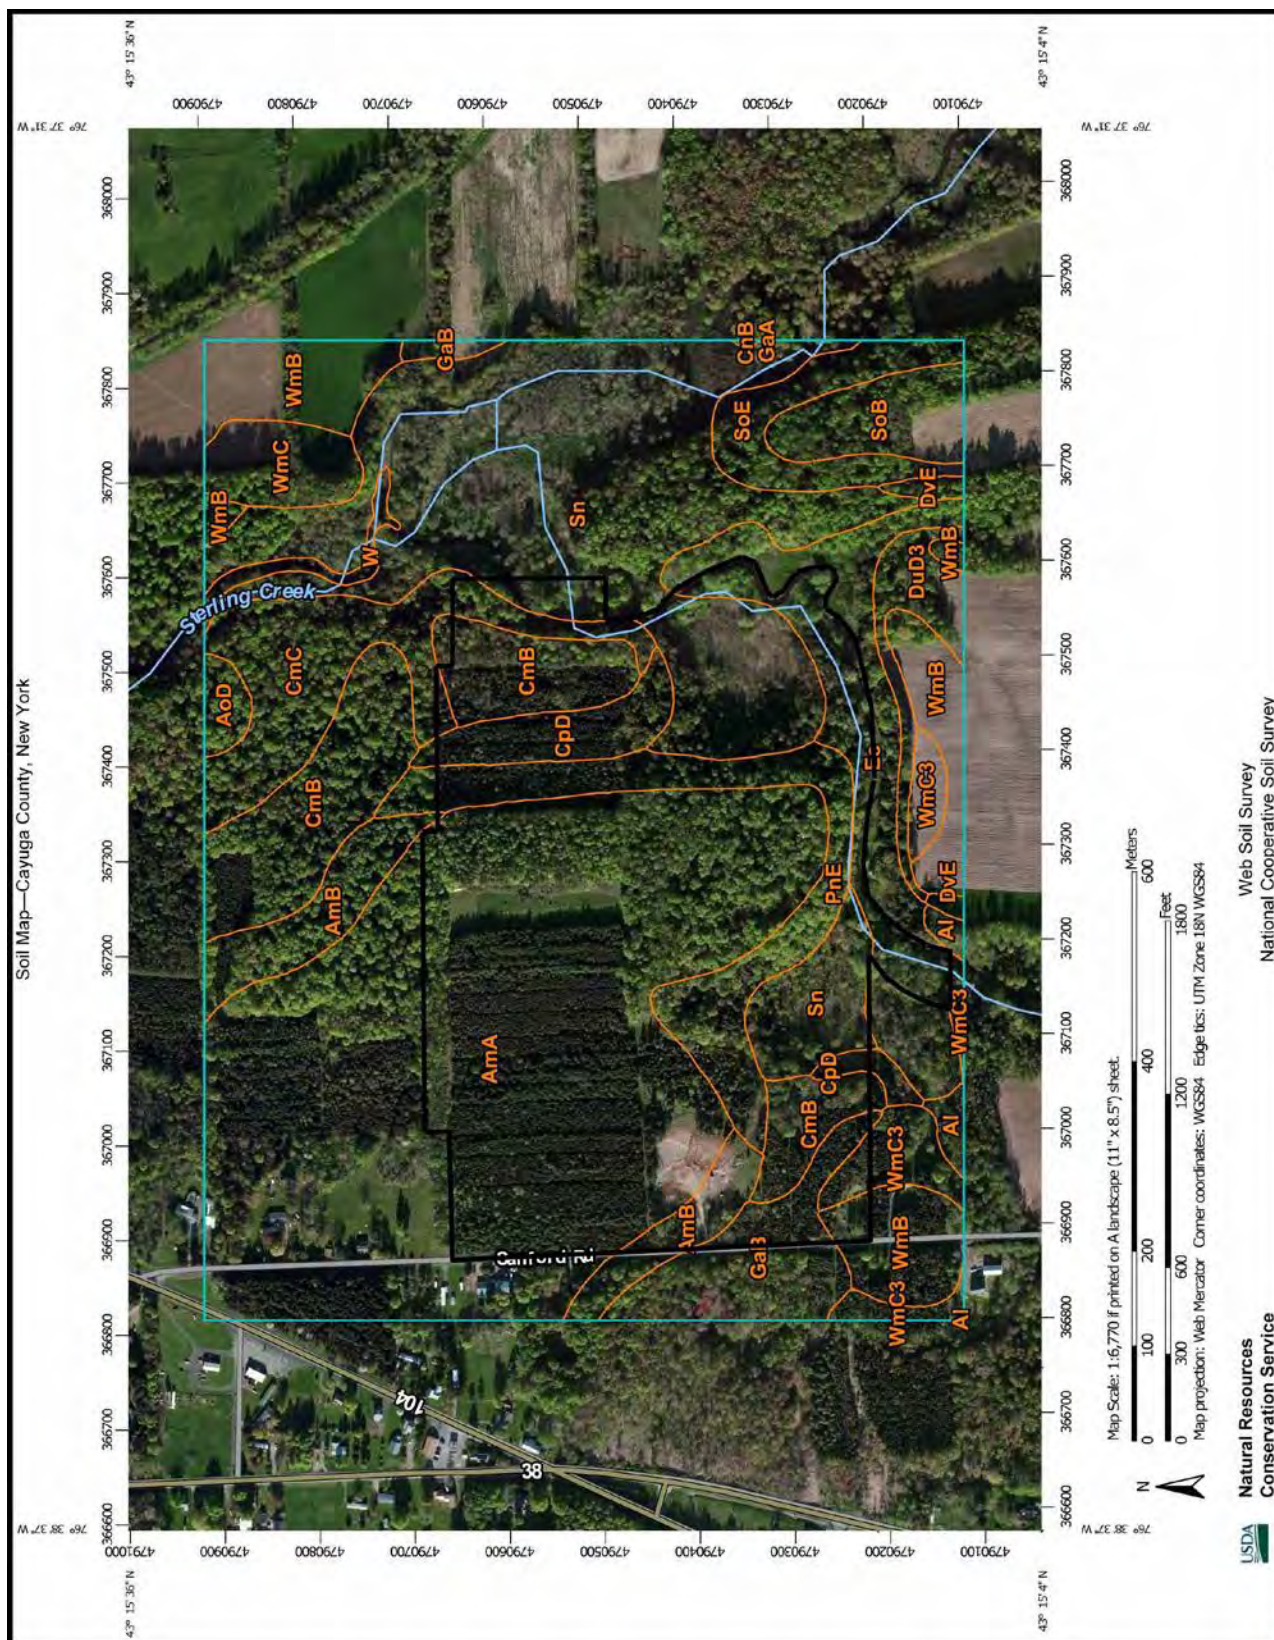
Figure 3. Location of the project area as shown on the Web Soil Survey.

The specific soils within the overall project area are Alton cobbly loam, 0 to 3% slopes (AmA); Alton cobbly loam, 3 to 8% slopes (AmB); Colonie loamy fine sand, 1 to 6% slopes (CmB); Colonie loamy fine sand, 6 to 12% slopes (CmC); Colonie and Arkport soils, 12 to 22% slopes (CpD); Eel silt loam (Ee); Galen fine sandy loam, 2 to 6% slopes (GaB); Palmyra, Howard and Alton soils, 25 to 40% slopes (PnE); Sloan silt loam (Sn); Williamson silt loam, 2 to 6% slopes (WmB); and Williamson silt loam, 6 to 12% slopes (WmC3) (Web Soil Survey; Hutton 1971:111-113, 115-116, 125-126, 129-130, 136-137, 141-142, 169-171, 177-178, and 184-185; Figure 3).

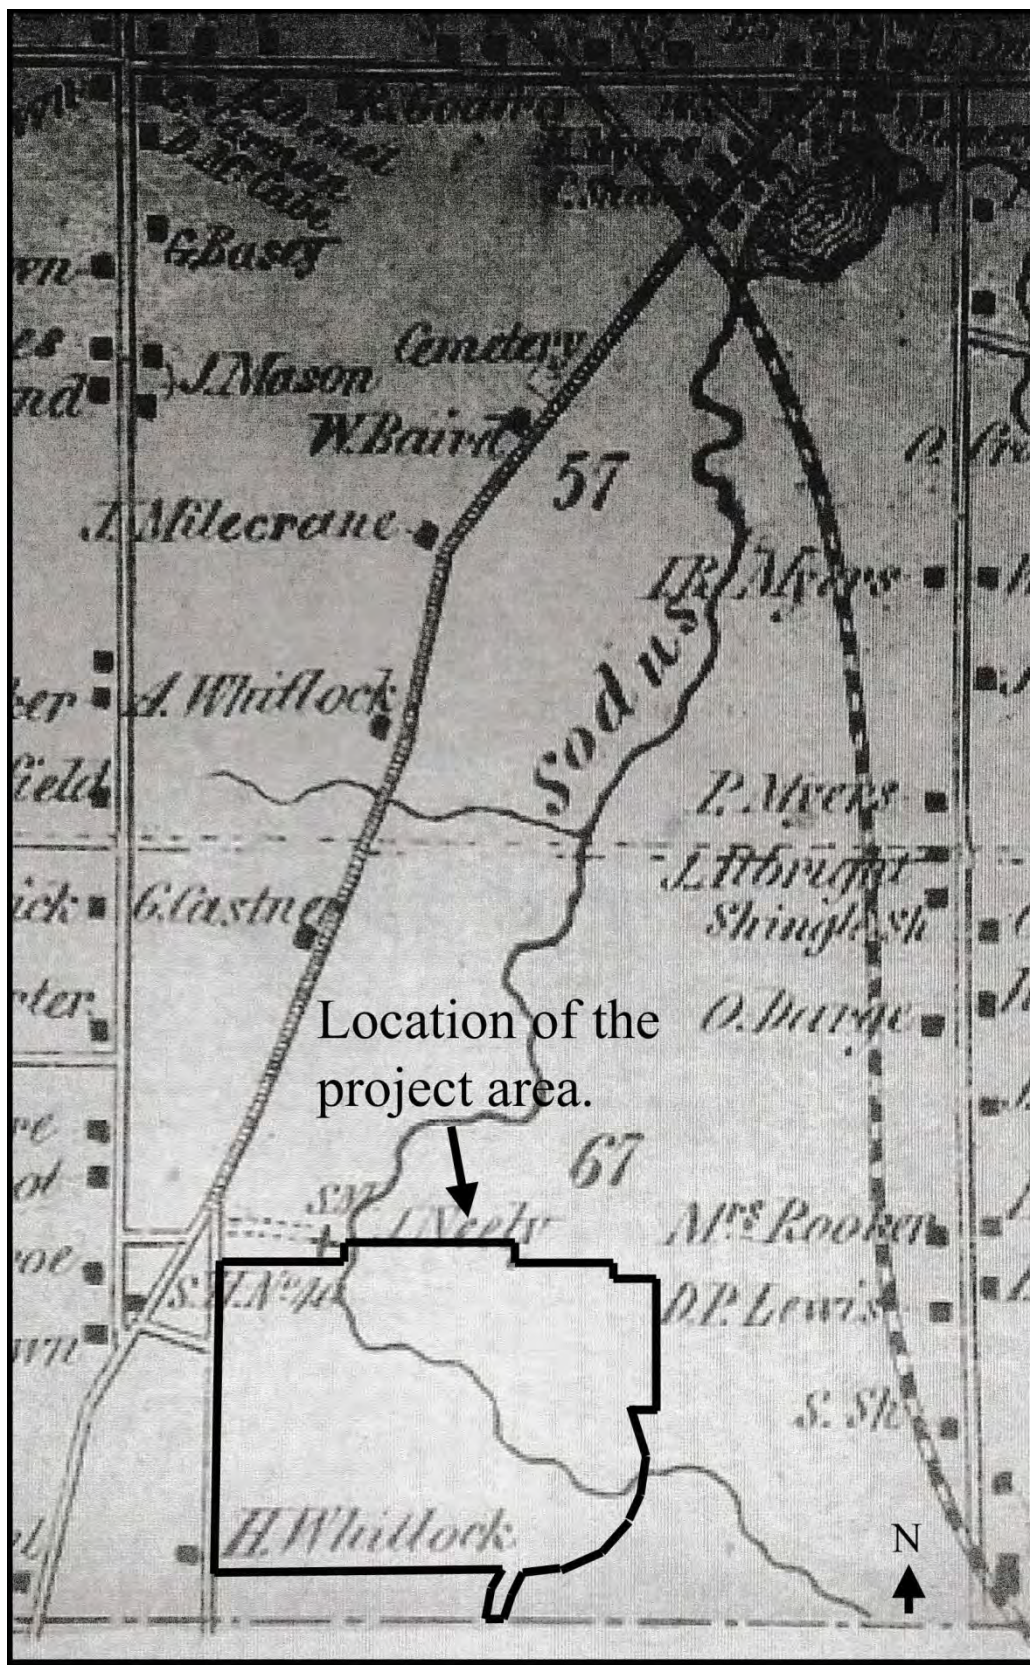
Figure 4. Location of the project area as shown on a portion of the 1853 *Map of Cayuga County, New York*.

Although no additional MDS are shown within the overall project boundaries on any of the available historic maps, a sawmill is shown to the north in 1853 (Figure 4). However, this structure is gone by 1859 (Figure 5). In 1875 (Figure 6) the R. Fry residence is shown to the north along the east side of Sanford Road. By 1900 (Figure 7) a private residence is still shown at this location and in 1904 (Figure 8) this residence is identified as belonging to W.H. Frye. A private residence is still shown at the location in 1960 (Figure 9) and on the modern topographic map (Figure 2). A private residence was still at this location during the original evaluation.
